Structure Name: *Ferry Lock*

Structure Ref: *L22A*

Canal Lock Inspection Report

Project
SANKEY CANAL RESTORATION

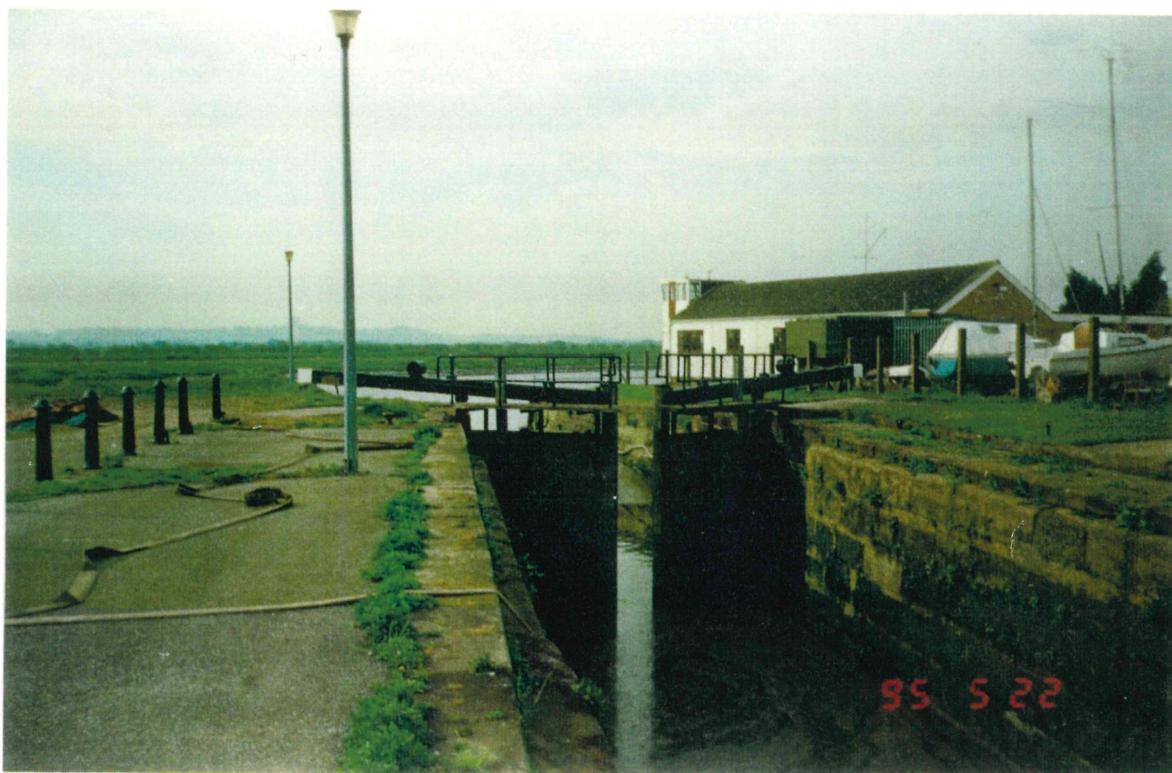
General Arrangement Photograph - Number 1/30

Part No	Name of Part	1-5 P-G	Condition Report	Photo Ref.
1	Chamber Walls	3.5	The walls are constructed from large masonry blocks with isolated areas of brick infill. There is minor vegetation growth in each wall.	1/31
2	Chamber Copings	3.5	The copings are in reasonable condition.	1/30
3	Chamber Invert	2	The chamber invert is heavily silted near the downstream lock gate.	1/30
4	Lock Gate Sills	4.5	The upstream sills are in good condition. The downstream sill is not visible for inspection.	1/31
5	Upstream Lock Gate	4	The lock gates are in good condition.	1/31
6	Downstream Lock Gate	4	The lock gates are in good condition although leakage cannot be assessed due to water levels.	1/30
7	Upstream Lock Gate Sluices	3	The sluice gears appear operational but there is moderate leakage around the sluice gates.	1/31
8	Downstream Lock Gate Sluices	4	The sluice gates appear operational.	
9	Ladders	4.5	The ladders to the chamber are in good condition.

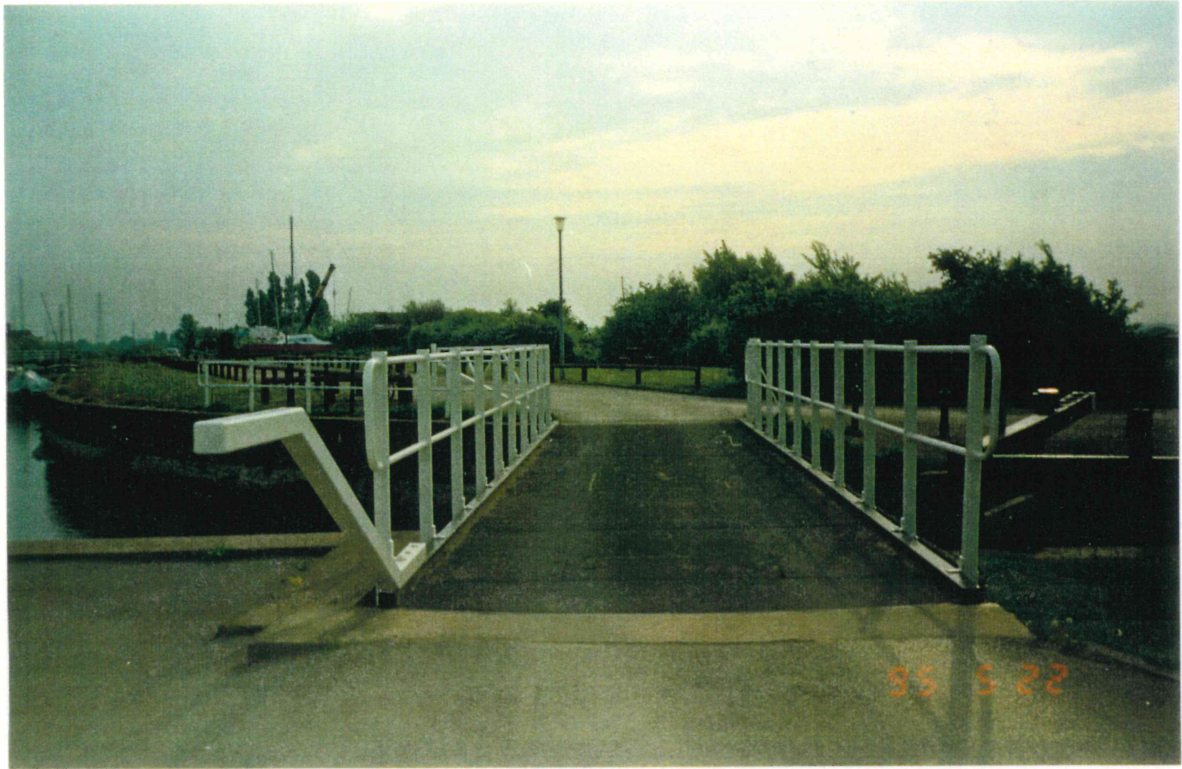
PHOTOGRAPH 1/28 - General Elevation of Carriageway

Part No	Name of Part	1-5 P-G	Condition Report	Photo Ref.
1	Invert		The canal invert is free from debris but the channel depth was not established.	
2	Aprons			
3	Foundation/Scour		The foundations were not exposed for inspection.	
4	Cutwaters			
5	Piers/Columns			
6	Abutments & Bankseats	4	The reinforced concrete abutments are in good condition.	
7	Wingwalls			
8	Embankments			
9	Training Walls			
10	Drainage Substructure		None visible.	
11	Parapets	5	The parapets are in good condition with no loss of paintwork evident. They do not comply with Department of Transport requirements for impact loads.	1/28
12	Bearings		The north abutment bearings were not visible for inspection.

Part No	Name of Part	1-5 P-G	Condition Report	Photo Ref.
25	Spandrel Walls			
26	Tie Rods			
27	Pointing			
28	Condition of Masonry			
29	Surfacing	4.5	The steel decking is overlaid with asphalt and is in good condition.	1/28
30	Footways		There are no footways provided to the superstructure.	
31	Towpath			
32	Stop Plank Grooves		None provided.	
33	Canal Banks	5	The canal banks adjacent to the structure are in good condition.	
34	Swing Bridge Pintle	4	There is minor debris around the pintle but this does not interfere with the operation of the structure.	
35	Tail Rails & Wheels		Not visible for inspection.	
36	Hydraulics		The swing bridge operates manually and there are no hydraulics provided.	
37	Swing Bridge Counterweights	4	The counterweights at the south support are not visible for inspection.	
38	Swing Bridge Buffer	4	The buffer is in good condition.

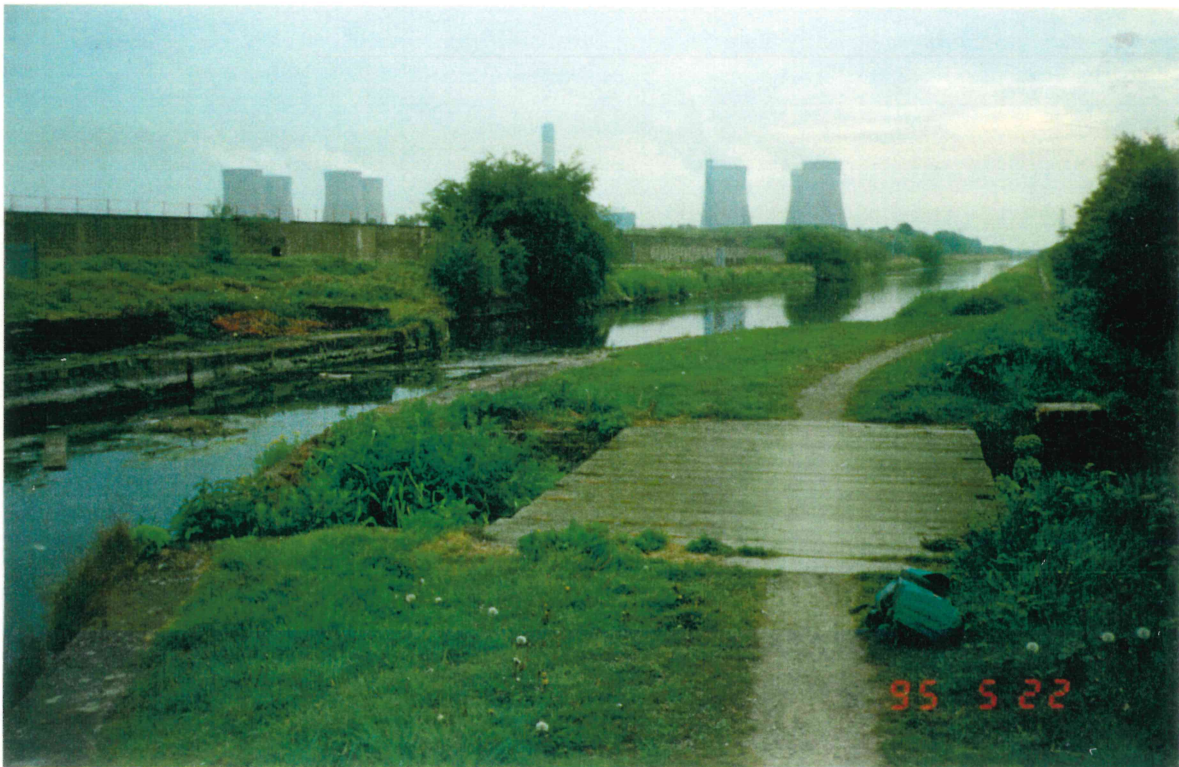
General Arrangement Photograph - Number 1/11

Part No	Name of Part	1-5 P-G	Condition Report	Photo Ref.
15	Main Beams	3	The timber edge beams appear to be in reasonable condition.	
16	Surfacing	4	The timber decking is in good condition.	1/11

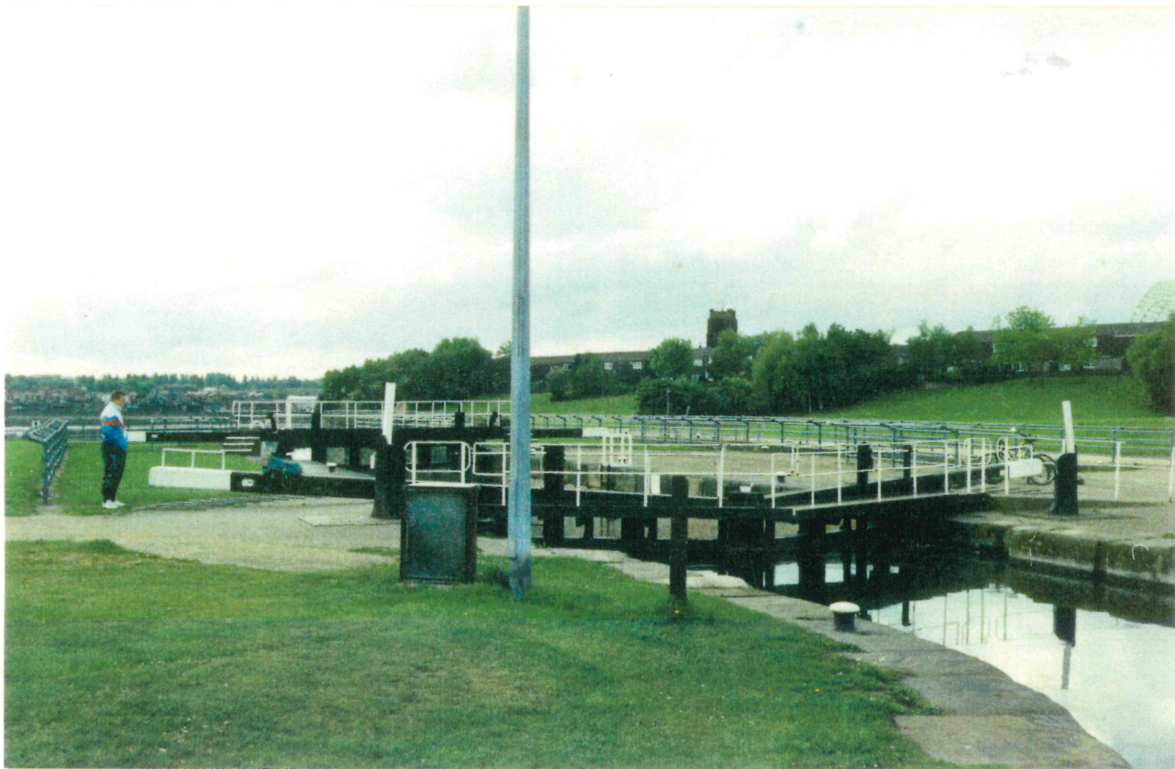
General Arrangement Photograph - Number 0/2

Part No	Name of Part	1-5 P-G	Condition Report	Photo Ref.
13	Bywash Weir		No bywash provided.	
14	Upstream Approach	5	Upstream approach is in good condition.	
15	Downstream Approach	2	Downstream approach into the River Mersey is heavily silted.	
16	Parapets	4.5	5 rail parapet provided around lock is in good condition. The tubular steel parapet to the lock gate footways is in reasonable condition with isolated areas of paint loss.	0/2
17	Towpath			
18	Condition of Masonry		See Sections 1 and 2.	
19	Pointing		See Sections 1 and 2.

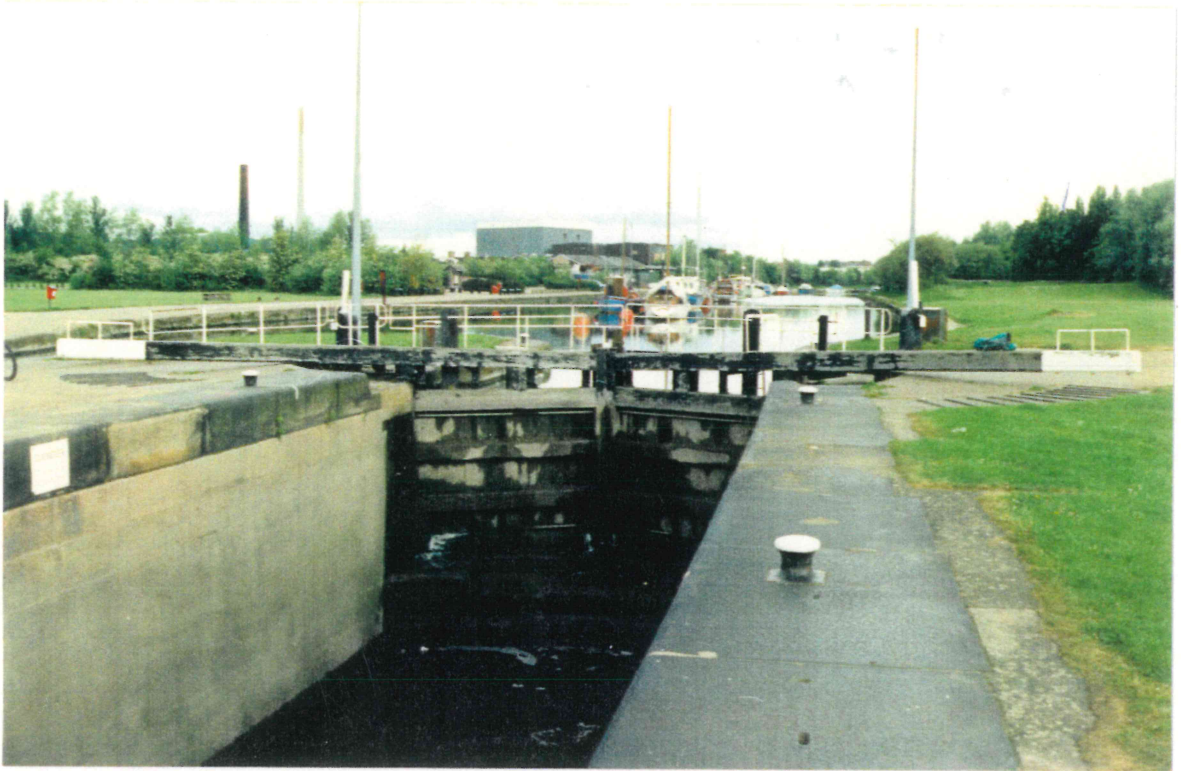
PHOTOGRAPH 0/1 - Upstream Lock Gate

Part No	Name of Part	1-5 P-G	Condition Report	Photo Ref.
1	Chamber Walls	5	Chamber walls in good condition. No significant mortar loss evident.	0/3
2	Chamber Copings	5	Original copings in good condition.	0/1
3	Chamber Invert		Not visible for inspection due to water level.	
4	Lock Gate Sills	4	Very minor leakage at the upstream sill. Downstream sill not visible for inspection.	
5	Upstream Lock Gate	4.5	Minor paint loss but the gates are generally in good condition.	0/1
6	Downstream Lock Gate	4.5	Minor paint loss but the gates are generally in good condition.	0/3
7	Upstream Lock Gate Sluices	4	Sluices in gate appear to be in good condition.	
8	Downstream Lock Gate Sluices	4	Sluices in gate appear to be in good condition.	
9	Ladders	5	Chamber ladder is in good condition.	0/3
10	Stop Plank Grooves	5	Upstream and downstream stop planks are in good condition.	
11	Chamber Wall Sluices			
12	Bywash Channel		No bywash provided.
